Manhole Inspection Summary

Manhole # S11YY1014MH

Insp Date: **7/19/06 9:59 AM**

Location Address: **2426 BRAMBLETON RD** Cross Street: **EVERHURST RD**

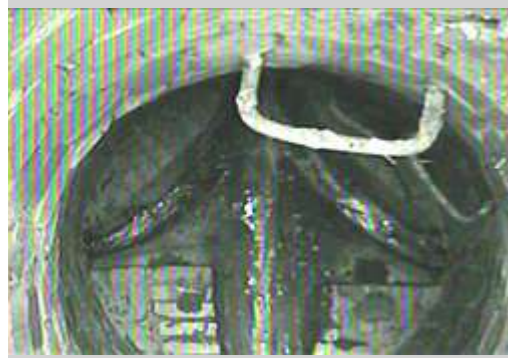
Top View

Steps Count: **4** Missing: **0** ☒ **Corroded**

Surcharge ☒ **Evidence Of Surcharge** Depth: **1** (ft.) ☐ Active Surcharge Present

Corroded steps. Evidence of surcharge - Bench debris.

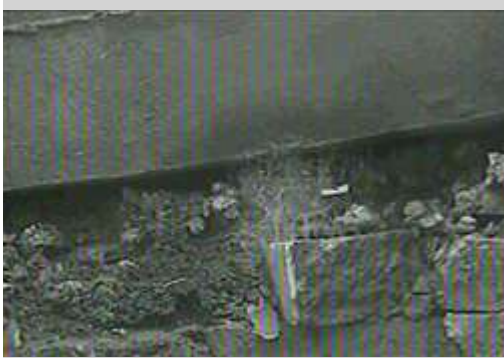
Defect

Frame Offset: **4** (in.) Condition: ☐ Sound ☐ Cracked ☒ **Leaks**

Chimney / Frame Adjustment ☒ Exists Material: **Brick** ☐ Parged Height: **8** (in.)
Condition: ☐ Sound ☐ Cracked ☐ Root Intrusion ☒ **Loose Brick** ☒ **Deteriorated**
Infiltration: ☐ None ☒ **Joint** ☐ Cracks ☒ **Mortar** ☐ Roots ☐ Wall

Frame leaks. Adjustment deterioration, loose brick and infiltration.

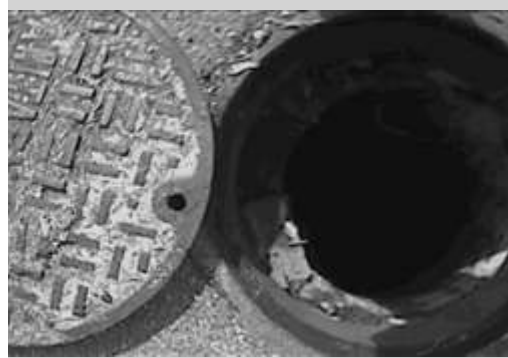
Defect

Frame offset.

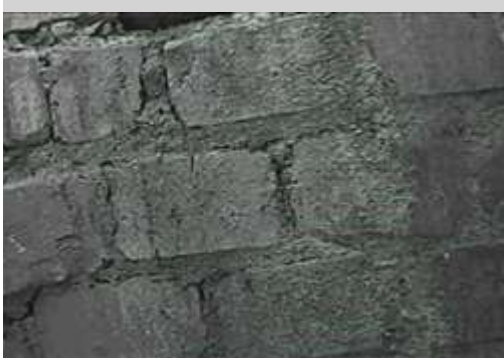
Defect

Corbel Material: **Brick** ☐ Parged Type: **Concentric/Eccentric**
Condition: ☒ Sound ☐ Cracked ☐ Root Intrusion ☐ Loose Brick ☐ Deteriorated
Infiltration: ☐ None ☐ Joint ☐ Cracks ☒ **Mortar** ☐ Roots ☒ **Wall**

Corbel infiltration.

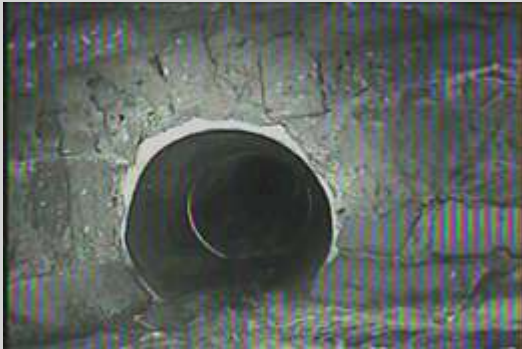
8 in. Circular Gravity Sewer Pipe Out @ 12 O'Clock

Channel root intrusion.

Infiltration: **None** Pipe Seal Cond: **Cracked**

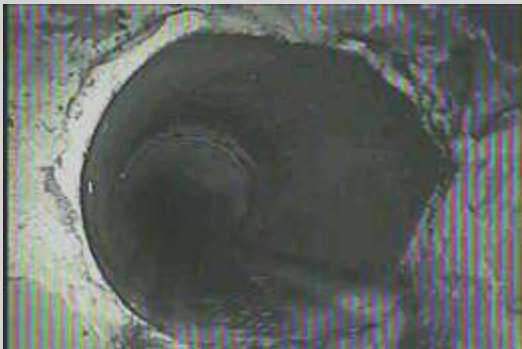
8 in. Circular Gravity Sewer Pipe In @ 3 O'Clock

Infiltration: **Evidence** Pipe Seal Cond: **Cracked**

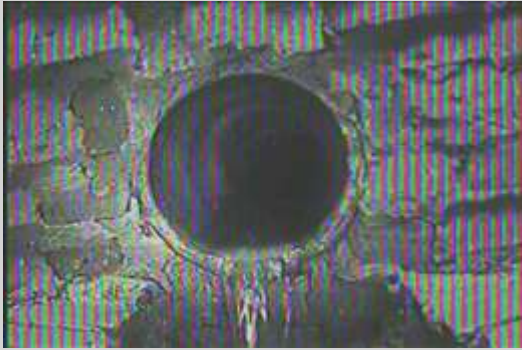
Pipe In @ 6 O'Clock

Barrel deterioration and infiltration..

Infiltration: **Evidence** Pipe Seal Cond: **Cracked**

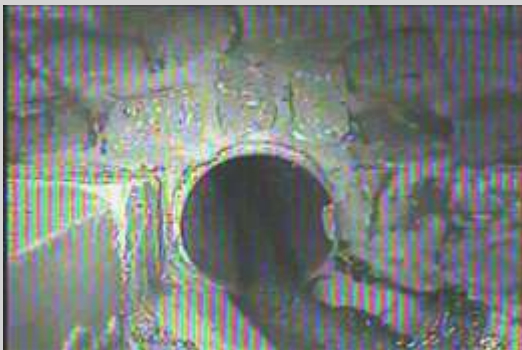
Pipe In @ 9 O'Clock

Barrel deterioration and infiltration. Channel deterioration and infiltration.

Infiltration: **Evidence** Pipe Seal Cond: **Unknown**
